CLOSE-OUT REPORT: NORTH AREA REVISION 0

LCP CHEMICALS-GEORGIA BRUNSWICK, GEORGIA

GeoSyntec Consultants Project No. GL0191-1451 December 1997

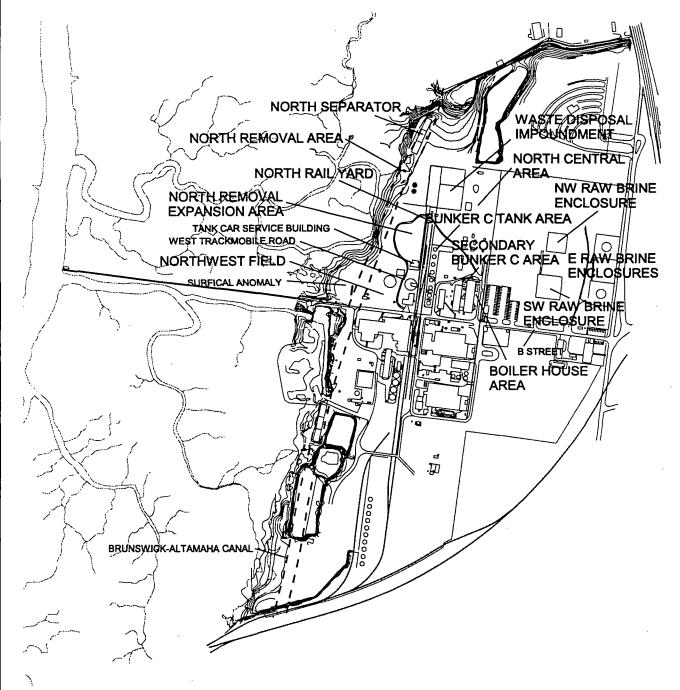
NORTH AREA SITE FEATURES

The excavation commenced at the former tank car service building and proceeded north (see Figure 1). The excavated material was temporarily stockpiled adjacent to the excavation area and sampled to determine the disposal route. When TCLP lead results from the stockpile samples failed the RCRA requirement for non-hazardous waste, treatability testing was performed on the material as discussed in Section 3.5.2 of this report. The excavated material stockpiles were relocated to the concrete slabs within the area to allow for excavation and backfill of the open excavation grids.

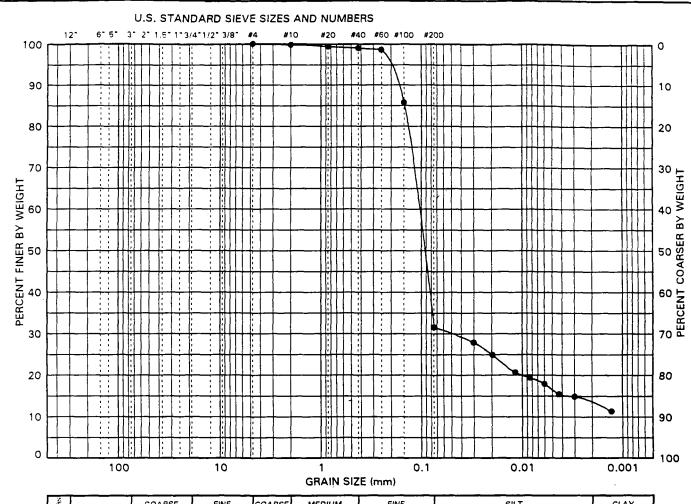
PARTICLE SIZE DISTRIBUTION AND PHYSICAL PROPERTIES

SITE SAMPLE ID *	LIQUID LIMIT (%)	28
LAB. SAMPLE NO. E95J02	PLASTIC LIMIT (%)	25
SAMPLE DEPTH (ft)	PLASTICITY INDEX	3
COUL CLACCIFICATION.

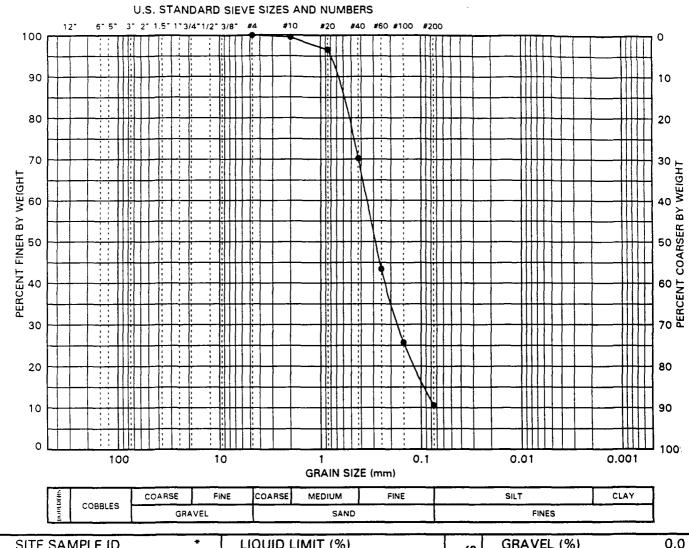
PARTICLE SIZE DISTRIBUTION AND PHYSICAL PROPERTIES

SITE SAMPLE ID *	LIQUID LIMIT (%)	တ	GRAVEL (%)	0.0
LAB. SAMPLE NO. E95J04	PLASTIC LIMIT (%)		SAND (%)	89.4
SAMPLE DEPTH (ft) 30-35	PLASTICITY INDEX		FINES (%)	10.6
SOIL CLASSIFICATION:		[\\ \\ \\ \\ \\ \\ \\ \\ \\ \\ \\ \\ \\	SILT (%)	
-		=	CLAY(%)	
		CO	EFF. UNIFORMITY (Cu)	5.0

PERCENT PASSING U.S. STANDARD SIEVE SIZES AND NUMBERS PERCENT FINER 3" 1.5" 3/4" 1/2" 3/8" #4 #10 #20 #40 #60 #100 #200 THAN HYDROMETER PARTICLE DIAMETER (mm) PERCENT PASSING SIEVE SIZES (mm) 0.020 0.005 0.002 0.001 0.150 0.075 0.050 75 50 37.5 25 19 12.5 9.5 4.75 2.00 0.850 0.425 0.250 100 100 100 100 97 70 43 26 11 100 100 100 100 100

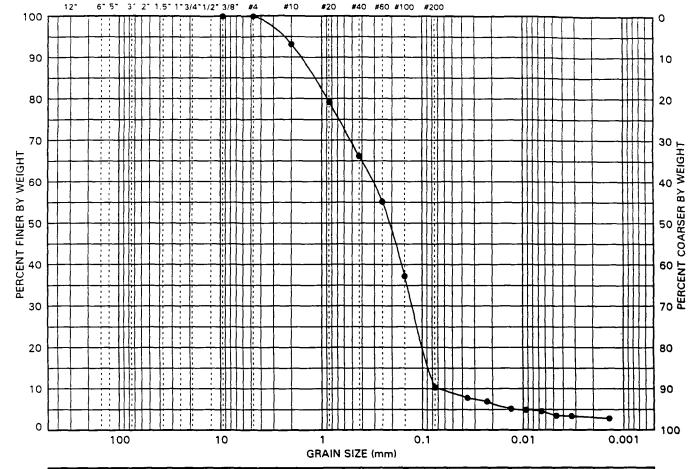
SITE SAMPLE ID *	LIQUID LIMIT (%)	NP
LAB. SAMPLE NO. E95J05	PLASTIC LIMIT (%)	NP
SAMPLE DEPTH (ft)	PLASTICITY INDEX	NP

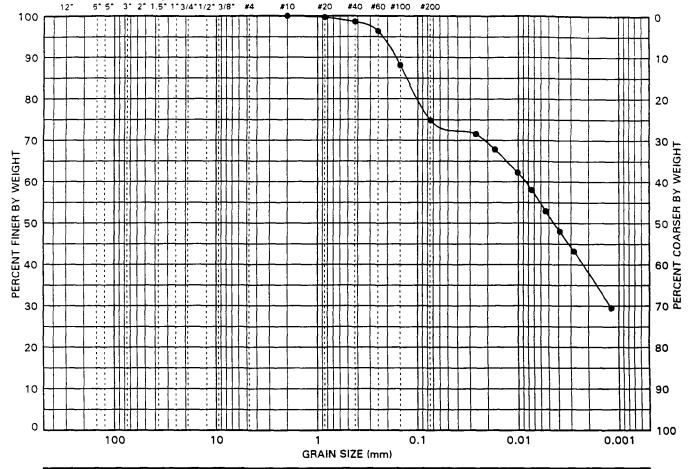
L	SITE SAMPLE ID	*	LIQUID LIMIT (%)	82	်	GRAVEL (%)	
	LAB. SAMPLE NO.	E95J06	PLASTIC LIMIT (%)	33	NO	SAND (%)	
Γ	SAMPLE DEPTH (ft)		PLASTICITY INDEX	49		FINES (%)	
Γ	SOIL CLASSIFICATION	ON.			A S	SILT (%)

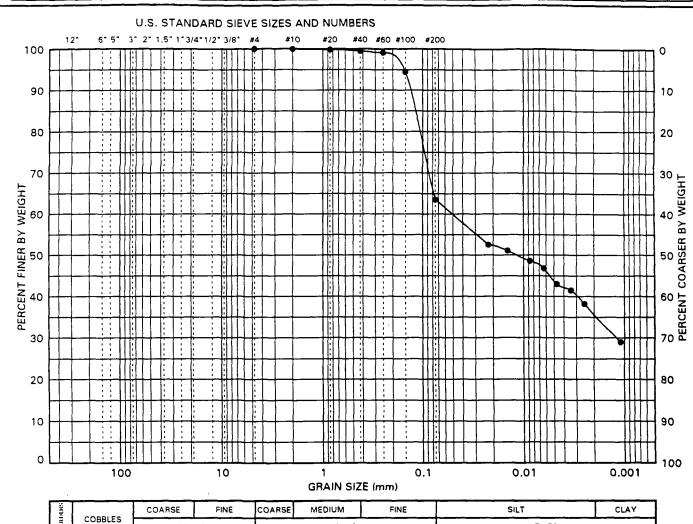
PARTICLE SIZE DISTRIBUTION AND PHYSICAL PROPERTIES

SITE SAMPLE ID	*	LIQUID LIMIT (%)	58
LAB. SAMPLE NO. E	95J09	PLASTIC LIMIT (%)	19
SAMPLE DEPTH (ft)		PLASTICITY INDEX	39

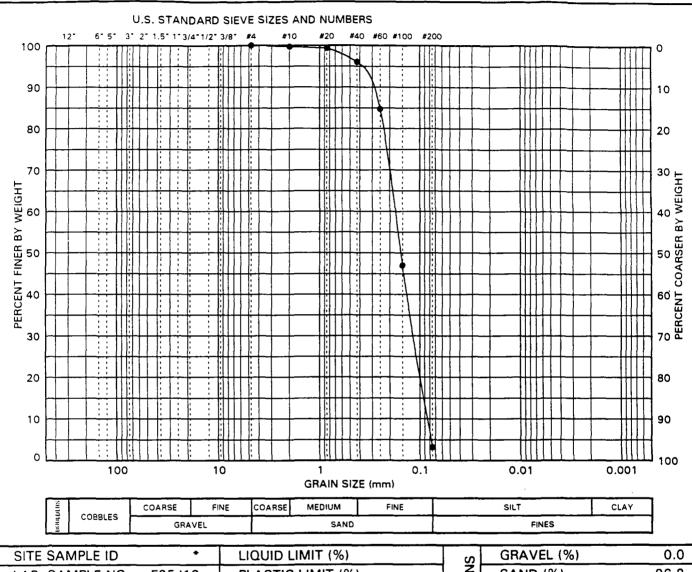
PARTICLE SIZE DISTRIBUTION AND PHYSICAL PROPERTIES

SITE SAMPLE ID	*	LIQUID LIMIT (%)
LAB. SAMPLE NO. E9!	5J10	PLASTIC LIMIT (%)
SAMPLE DEPTH (ft)	8-18	PLASTICITY INDEX
SOIL CLASSIFICATION:

FRACTIONS 96.8 **SAND (%)** SOIL 3.2 FINES (%) SILT (%) CLAY(%)

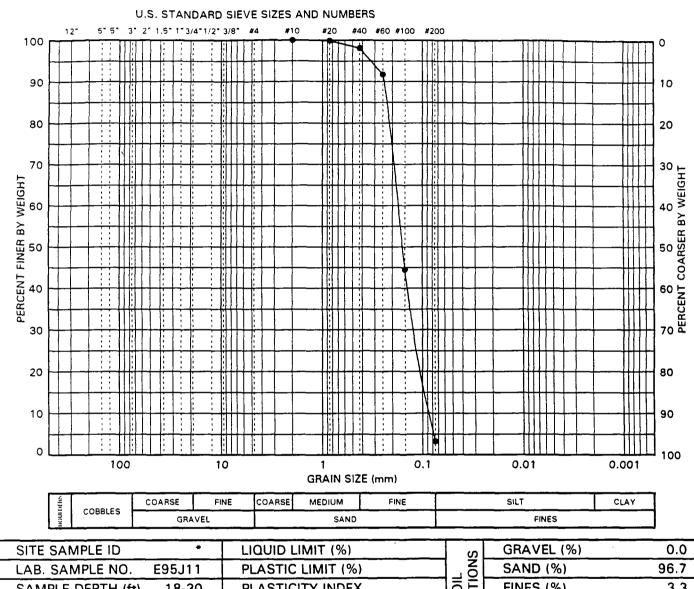
PARTICLE SIZE DISTRIBUTION AND PHYSICAL PROPERTIES

SITE SAMPLE ID	•	LIQUID LIMIT (%)	s	GRAVEL (%)	0.0
LAB. SAMPLE NO.	E95J11	PLASTIC LIMIT (%)	NO NO	SAND (%)	96.7
SAMPLE DEPTH (ft)	18-30	PLASTICITY INDEX		FINES (%)	3.3
SOIL CLASSIFICATIO	N:		S S S	SILT (%)	
SP - Poorly	Graded San	d		CLAY(%)

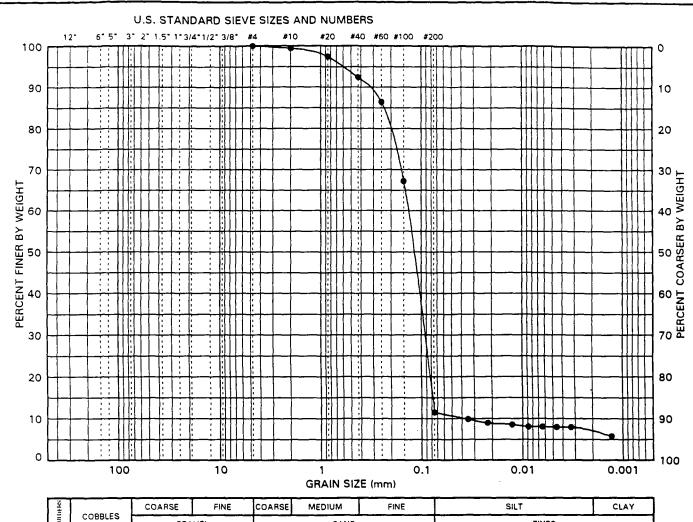
PARTICLE SIZE DISTRIBUTION AND PHYSICAL PROPERTIES

SITE SAMPLE ID *	LIQUID LIMIT (%)	NP	_[
LAB. SAMPLE NO. E95J13	PLASTIC LIMIT (%)	NP	$]_{_{-}}$
SAMPLE DEPTH (ft)	PLASTICITY INDEX	NP] <u> </u>
COUL OF A SCHEIC A TION!			70

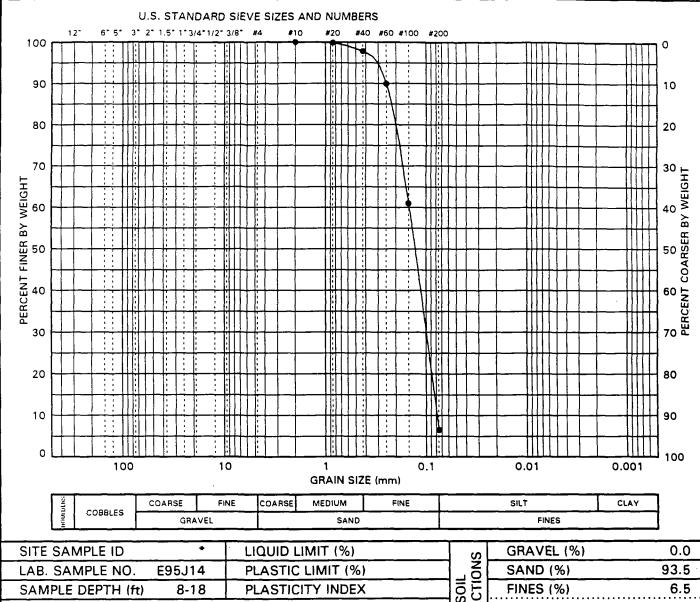
PARTICLE SIZE DISTRIBUTION AND PHYSICAL PROPERTIES

SITE SAMPLE ID *	LIQUID LIMIT (%)	- S	GRAVEL (%)	0.0
LAB. SAMPLE NO. E95J14	PLASTIC LIMIT (%)		SAND (%)	93.5
SAMPLE DEPTH (ft) 8-18	PLASTICITY INDEX		FINES (%)	6.5
SOIL CLASSIFICATION:	AS S	SILT (%)		
-			CLAY(%)	
1	CC	EFF. UNIFORMITY (Cu)	1.9	
		CC	EFF. CURVATURE (Cc)	0.88

PERCENT PASSING U.S. STANDARD SIEVE SIZES AND NUMBERS										PERC	ENT F	INER						
3"	2"	1.5"	1"	3/4"	1/2"	3/8"	#4	#10	#20	#40	#60	#100	#200	TI	H NAH	IYDRC	METE	R
	PERCENT PASSING SIEVE SIZES (mm)								PAR	TICLE	DIAM	ETER	(mm)					
75	50	37.5	25	19	12.5	9.5	4.75	2.00	0.850	0.425	0.250	0.150	0.075	0.050	0.020	0.005	0.002	0.001
100	100	100	100	100	100	100	100	100	100	98	90	61	7

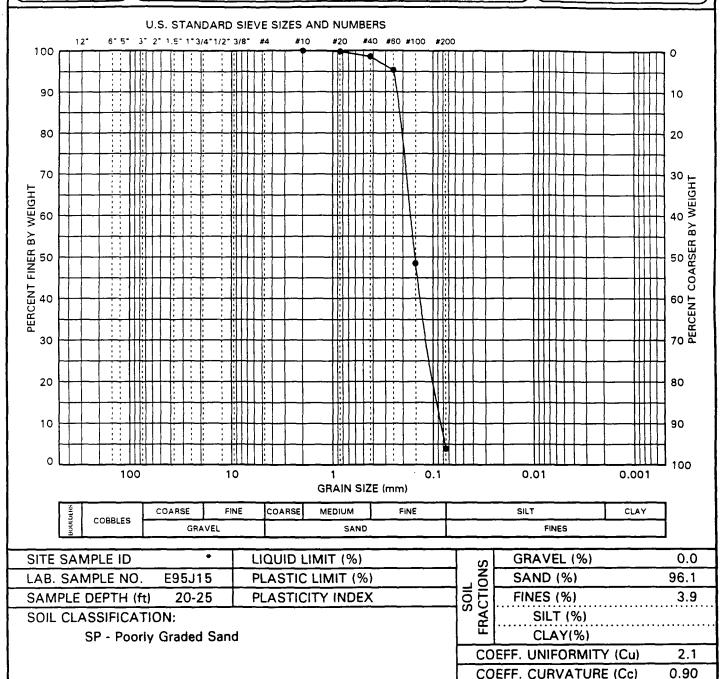
PARTICLE SIZE DISTRIBUTION AND PHYSICAL PROPERTIES

PERCENT PASSING U.S. STANDARD SIEVE SIZES AND NUMBERS										PERC	ENT F	INER						
3"	2"	1.5"	1"	3/4"	1/2"	3/8"	#4	#10	#20	#40	#60	#100	#200	TI	HAN H	IYDRO	METE	R
	PERCENT PASSING SIEVE SIZES (mm)								PAR ¹	ΓICLE	DIAM	ETER	(<u>mm)</u>					
75	50	37.5	25	19	12.5	9.5	4.75	2.00	0.850	0.425	0.250	0.150	0.075	0.050	0.020	0.005	0.002	0.001
100	100	100	100	100	100	100	100	100	100	99	95	49	4

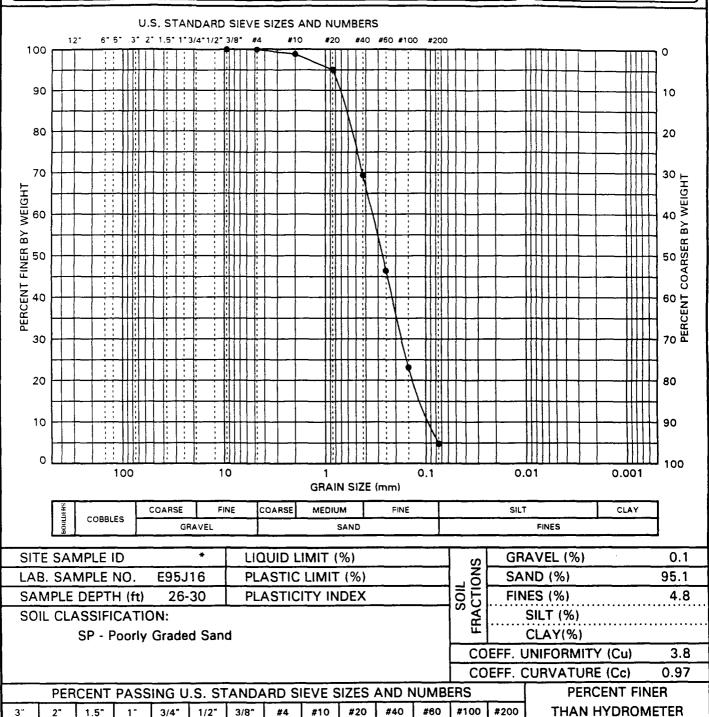
0.850 0.425 0.250 0.150 0.075 0.050 0.020 75 12.5 9.5 4.75 2.00 50 37.5 19 25 100 100 100 100 100 46 23 5 100 100 NOTES: * 950276-NDB4-D
